## Inspection of main landing gear assembly

All SHARK types and models

**This revision supersedes the previous revision of SHARK\_SB\_010.**

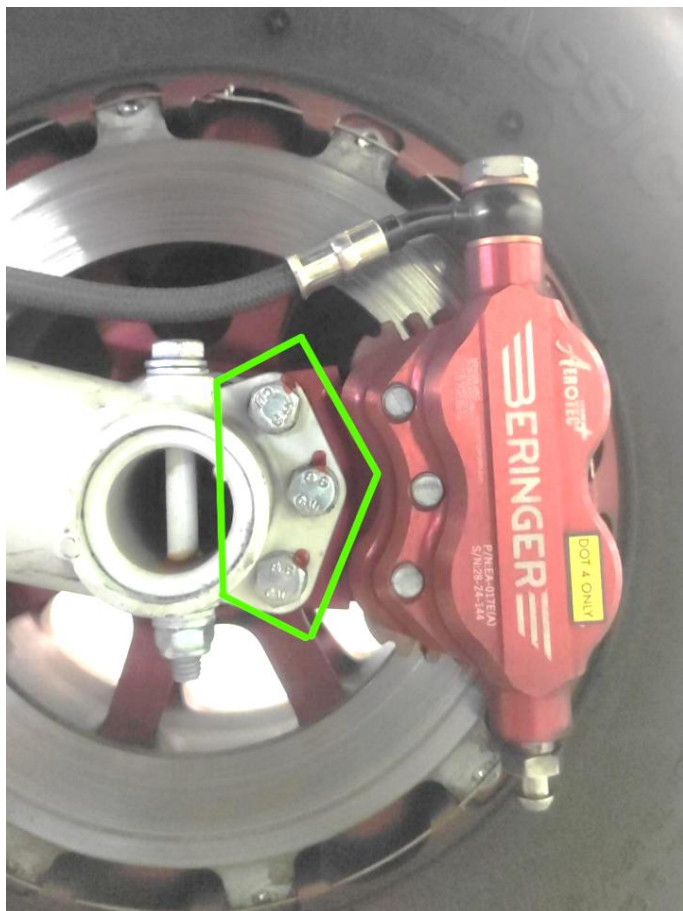
**1. Caliper bolts:** On some production batches of SHARK aircraft, Nord-Lock washers in combination with Loctite were used to secure the three bolts attaching the brake caliper to the landing gear leg. It was found that this method of securing may not be sufficient. Possible loosening of the bolts can be monitored by visual inspection of the red torque marking applied on the bolt heads. Excessively loose bolts may come into contact with the wheel disc and cause damage to the disc.

**WRONG**

- Remove existing bolts.
- Replace with bolts mutually safety-wired using locking wire.
- Replacement bolts will be supplied by SHARK.AERO on request.

Brake: 6 pcs bolts - DIN 912 **M6x35, Steel Zinc plated with thick Cr(III+) passivation, Class 8.8**  
(supplier for example FABORY, Article number **07067.060.035**)  
**Shorten bolts from 35 mm to 20 mm**  
Drill a 1.2–1.6 mm diameter hole through the bolt head, centred at mid-height of the head,  
for safety wire installation.  
6 pcs washers – DIN 125, M6, Stainless steel

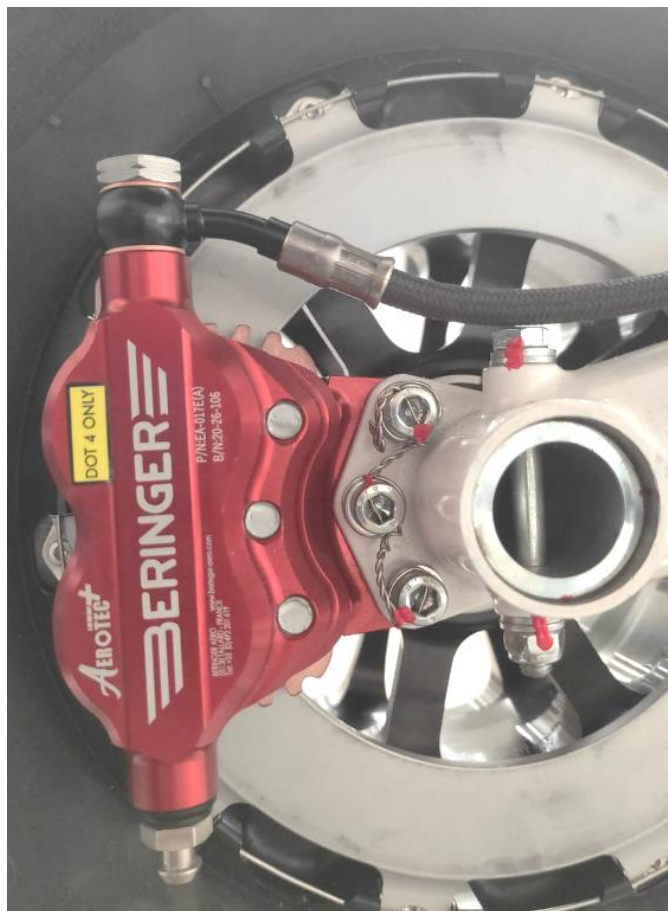
**CORRECT**

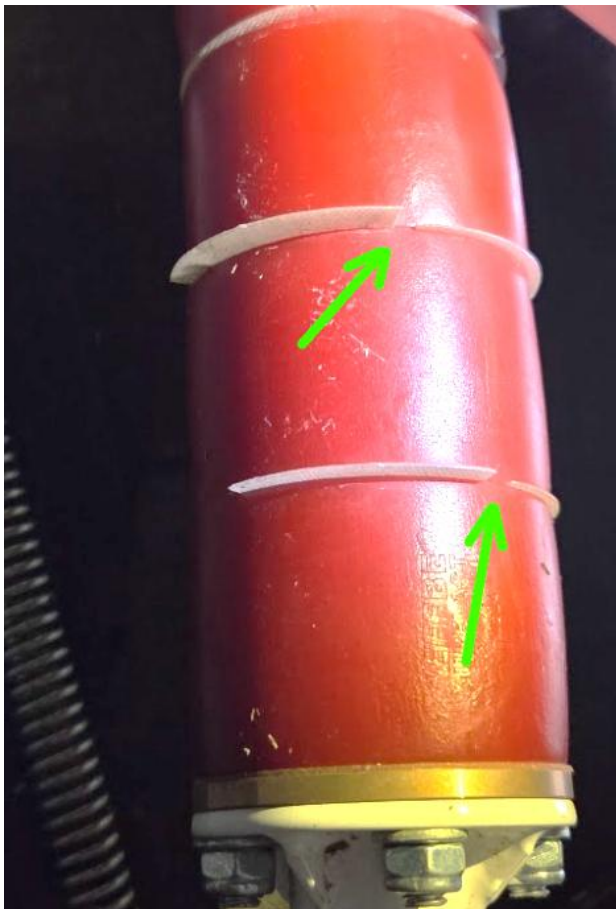
**2. Friction washers:** Some shock absorbers are equipped with friction washers made of insufficiently thin material. This condition may lead to cracking of the washers and their displacement out of the damper contour.

**WRONG**

- Remove the shock absorber.
- Replace all friction washers.
- Replacement washers and detailed replacement instructions will be supplied by SHARK.AERO on request.

Shock absorber: 2 sets of washers S6-03-653

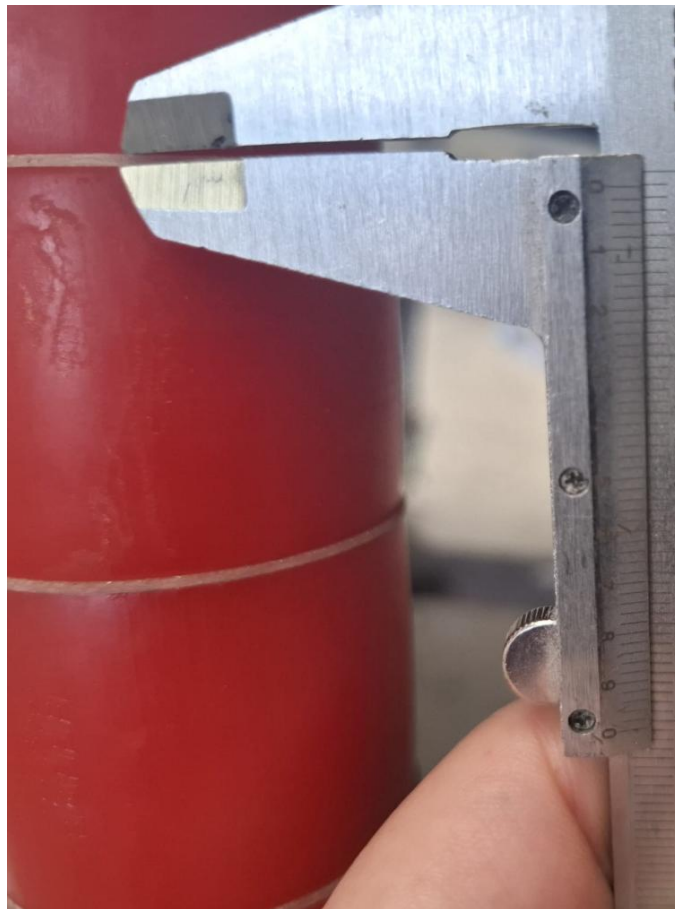
**CORRECT**
