## Inspection of wire loom clearance

Date:  
15/12/2025

All SHARK types and models equipped with Rotax 912 series engine.

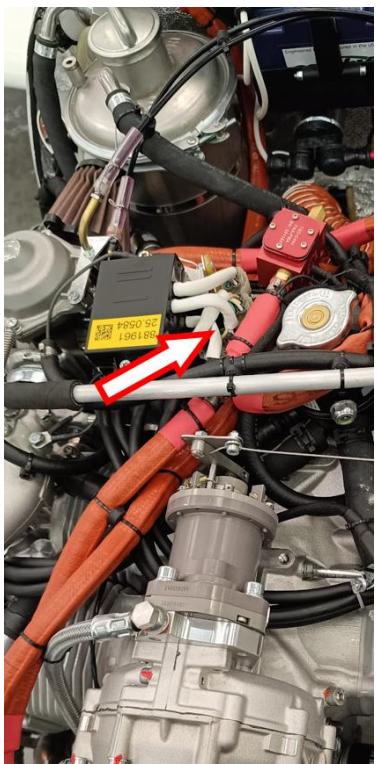
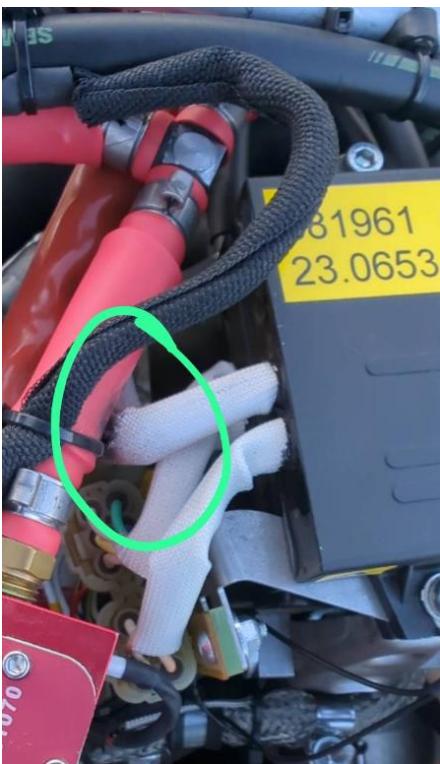
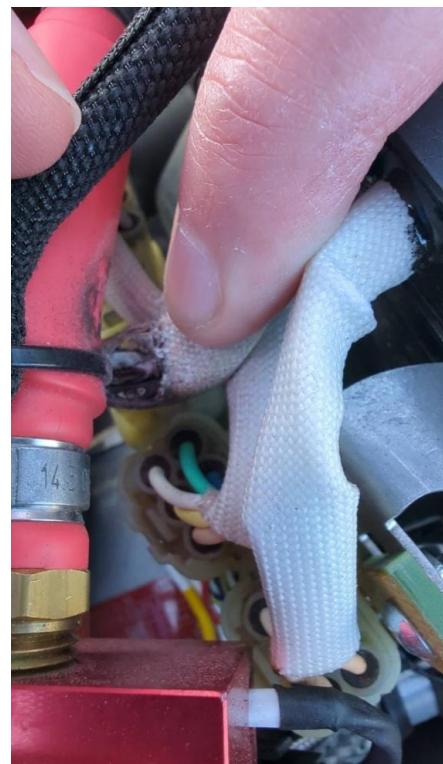
On some SHARK aircraft, damage to the outer insulation of the engine electronic module wires (Rotax 912) has been reported. The damage was caused by contact between the wire loom and the fuel hose, combined with vibration during engine operation.

In some aircraft, the wire loom of the engine electronic module is routed close to, or in contact with, the fuel hose. If the clearance is too small or contact occurs, vibration can cause abrasion of the wire insulation.

Even if no damage is found but clearance is insufficient, the fuel hose must be repositioned and secured to achieve safe separation.
