Inspection of fuel hoses

16/01/2026

All SHARK types and models.

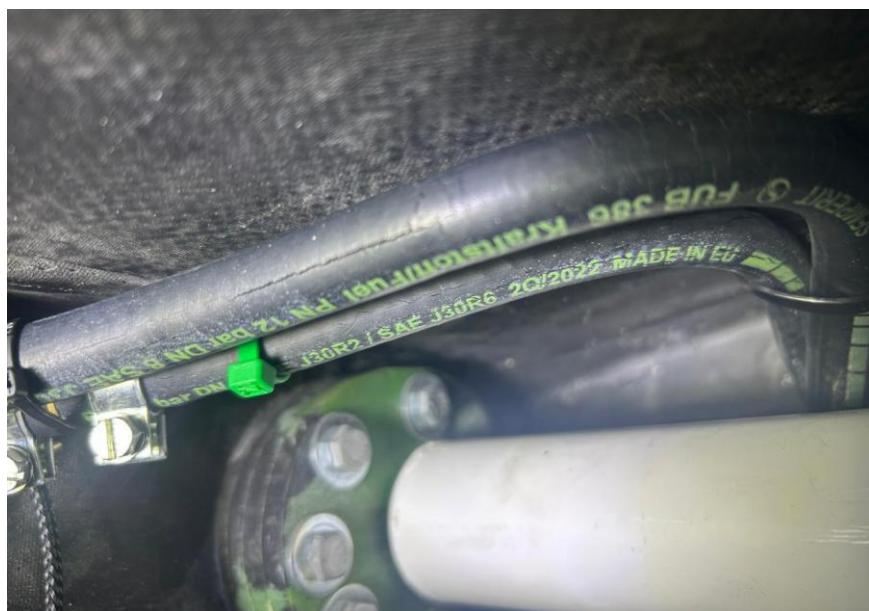
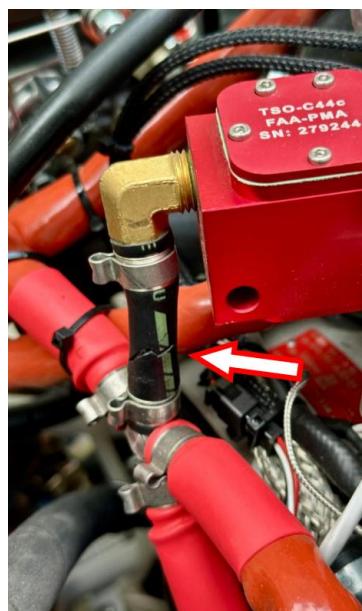
Cracks have been found on various fuel hoses installed on some SHARK aircraft.

The main suspected cause is a defective batch of SEMPERIT hoses. All cracking has been observed in the outer rubber sheathing of the hoses.

No fuel leakage has been detected, even on hoses exhibiting extensive surface cracking. All affected hoses were noticeably hardened.

- Inspect hoses H1–H12 and H16. They can be easily accessed for visual inspection, as they are located inside the main landing gear bays and cockpit. Check these hoses first and verify if they are of SEMPERIT manufacture. The condition of these hoses will indicate whether similar issues may be expected on the remaining hoses.
- Inspect hoses H13–H20 in the engine compartment. **It is not required to remove or cut the fire sleeve.** Cut the shrink tube or tape at the end of the Pyrosil sleeve and pull the sleeve back approximately one-third of the hose length to inspect the hose surface

- Examine the outer rubber surface for hardening, cracks, cuts, or any other signs of deterioration or damage.
- If no cracks or damage are found, reseal the ends of the inspected hoses using Pyrosil adhesive tape. All hoses may remain in service; however, the short hose H17 must be checked regularly during pre-flight inspections and scheduled maintenance checks as an indicator of possible future hardening and/or cracking.
- If any cracks or damage are found:
 - It is likely that all affected hoses originate from the defective batch. In this case, replace all SEMPERITE fuel hoses through an appropriately authorized maintenance person or directly at SHARK.AERO.
 - SHARK.AERO will provide a replacement hose set and necessary materials free of charge.
